INTERIM REPORT ON BASIN F

An Analyses of the Subsurface Investigations
Conducted Around Basin F

March, 1978

Geohydrology Division
Contamination Control Directorate
Rocky Mountain Arsenal

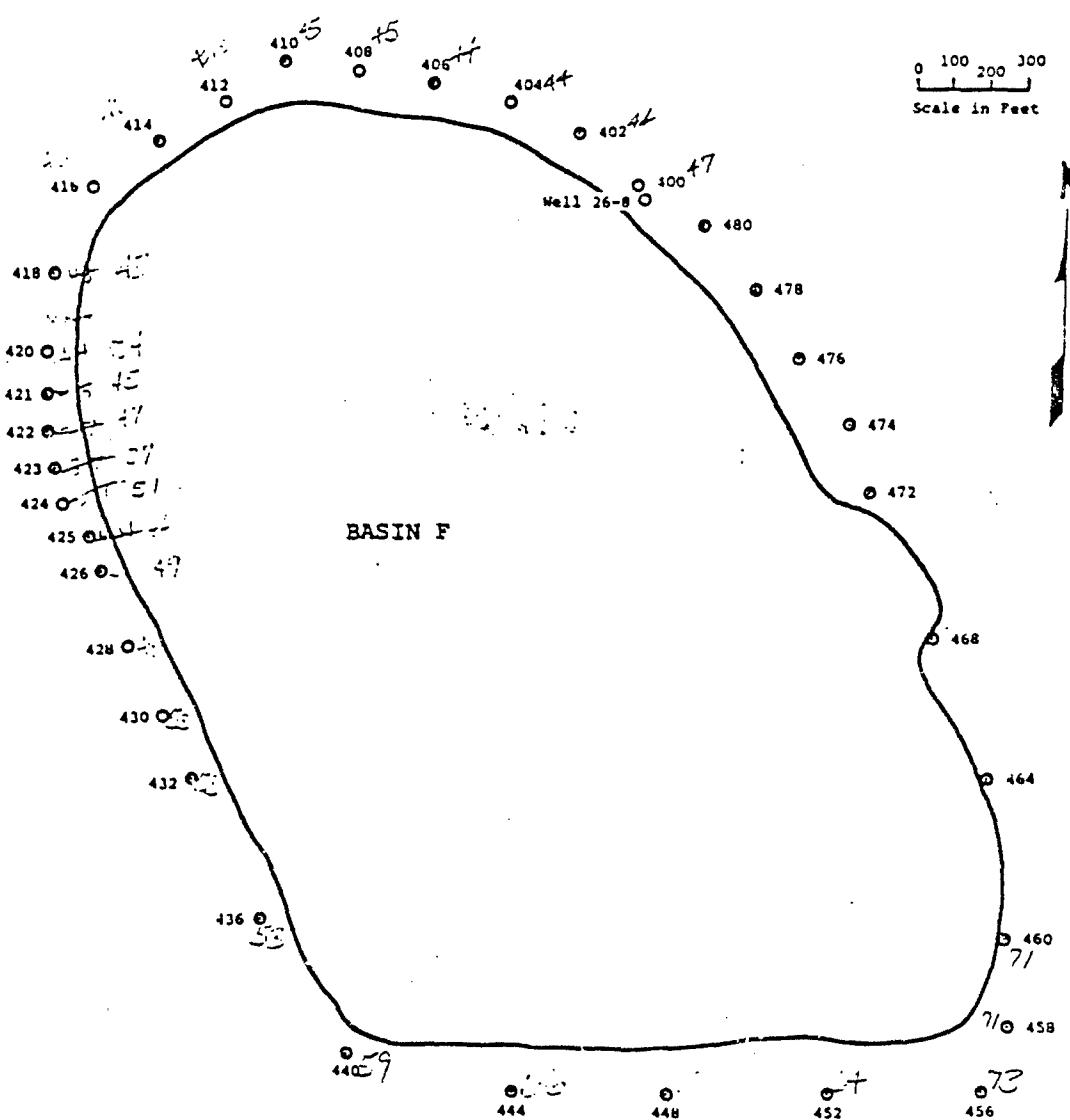
Figure No 1. Location of Boring Sites

To evaluate the groundwater conditions in the vicinity of Basin F, 27 of the 35 sites had monitoring wells installed in them (Figure 1). The monitoring wells consist of two-inch diameter PVC pipe with a four-foot length of slotted screen at the bottom. In some wells a length of solid plastic pipe extends below the screen to act as a sand trap. These wells are installed in such a manner so that the bottom of the screened interval coincides with the top of interpreted bedrock. The well installed in boring 458 is completed at a depth of 76 feet, which is about 40 feet below the top of the interpreted bedrock. The significance of this well is discussed in the section dealing with the hydrologic setting in the vicinity of Basin F.

In order to understand what the groundwater conditions are in the vicinity of Basin F, 27 monitoring wells were installed around its perimeter (Figure 1). These wells are used for both water quality and water level determinations. The purpose of the water analyses was to determine the distribution of potential contaminants around the basin and possibly identify leakage points around it. Determining the groundwater potentials that exist around the basin is also necessary to relate the water chemistry to where it occurs in the flow system. For example, different contamination levels may indicate a downgradient diffusion from a single exit point or indicate several leakage points where the groundwater gradient and apparent diffusion gradient do not coincide.

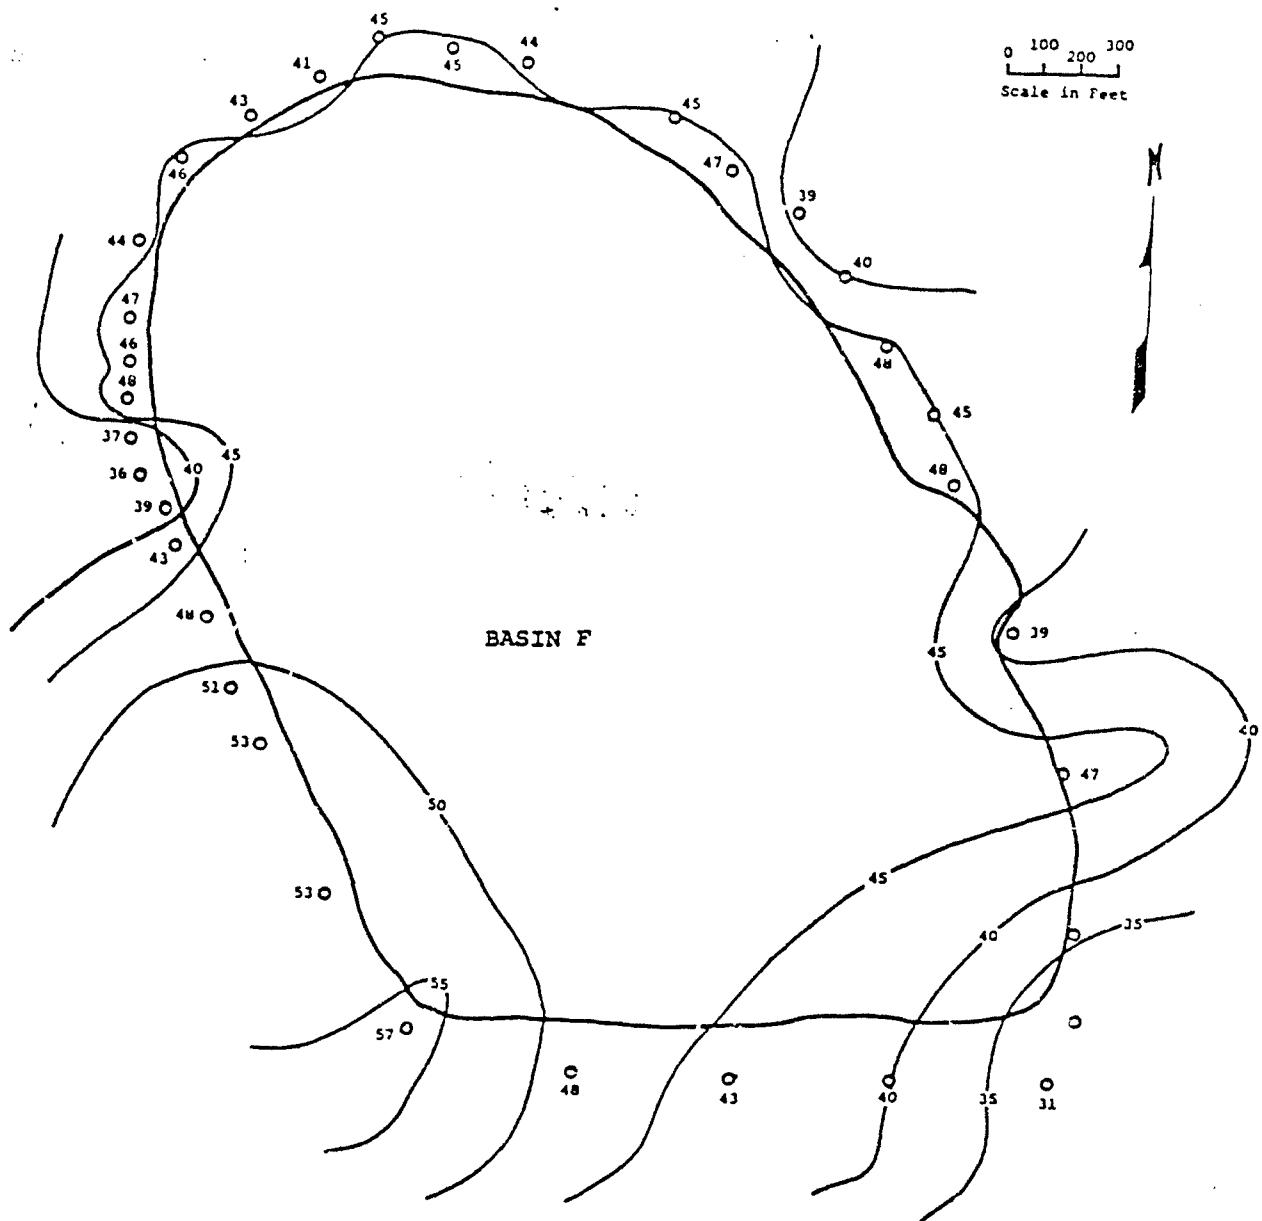
Figure No 2. Elevation of Mudstone (CH) Layer ,

The significance of these findings lie in the fact that some of the previously identified bedrock channels are not channels at all but simply areas where the bedrock consists of sand and silt rather than clay. This may or may not have profound effects on the interpretations dealing with contaminated groundwater flow at RMA. Specifically, in the vicinity of Basin F, the fact that bedrock materials are this variable affects the design and location of a full-depth containment system.

Figure 2 is a contour map showing the elevation of the mudstone (CH) layer that has traditionally been identified as bedrock. If full-depth containment of the basin is deemed necessary, this is the elevation to which a barrier would have to be completed to insure hydrologic integrity.

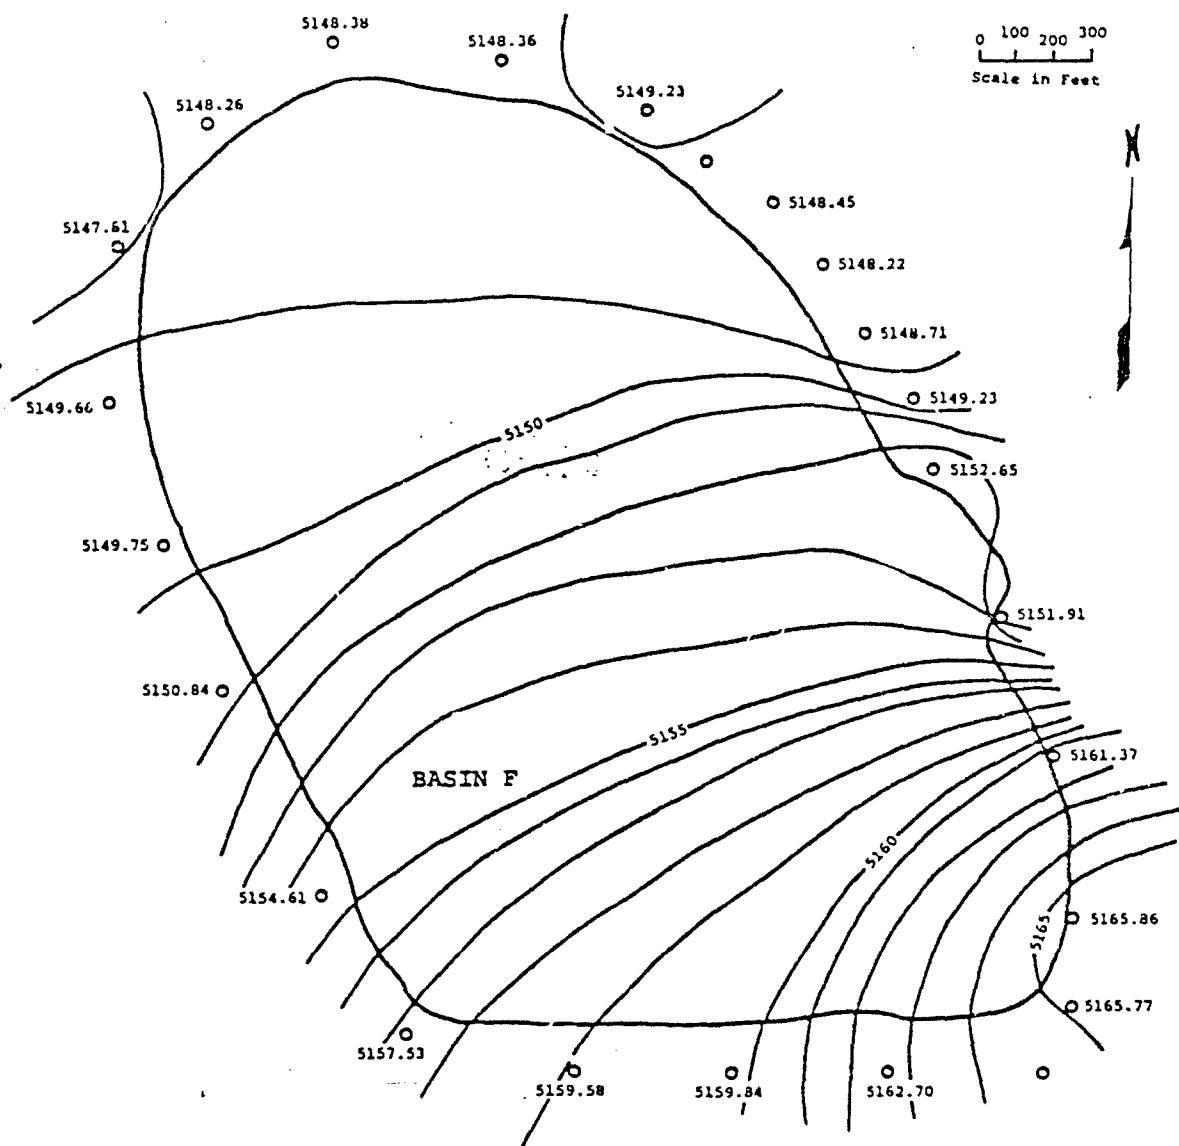
Figure No 3. Water Table Elevations

The groundwater pattern in the vicinity of Basin F as shown in Figure 3 is interpreted only on the basis of the monitoring wells around the perimeter. Water-table data that might be collected utilizing additional points away from the basin could significantly alter the interpretation. For example, if groundwater mounding occurs as a result of the existence of Basin F, groundwater flow components would be outward from the reservoir in an essentially radial pattern. Isolated leakage points that might contribute significant quantities of fluid to the groundwater system over small areas can also affect the distribution of the hydraulic heads and their interpretation. The interpretation as shown in the illustration assumes that groundwater mounding has not

The principal flow component underneath Basin F is in a northerly direction. Along the north side of the basin a groundwater divide occurs and results in two principal flow components, one in a north-westerly direction towards the northwest boundary, and the other in a northeast direction towards the north boundary. Along the east side in the vicinity of borings 468 to 474, a minor northeast flow component occurs. Minor west and northwest flow components occur along south and southwest of Basin F, respectively.

The gradients on the water table vary between a high of about 0.04 to less than 0.002. The average gradient is about 0.01. The steepest gradient occurs in the vicinity of the southeast corner of Basin F and may relate to the fact that this is the area in which the fine to medium grained bedrock sand occurs. As this material undoubtedly has a lower permeability than the surface aquifer gravelly sand, the gradient has to be steeper to account for the volume of water entering along the south and exiting along the north, plus whatever fluid volume is contributed by the basin itself. The area of steeper gradients may define the extent of the bedrock sand underneath Basin F, and where the gradients become shallow may define where the hydraulic connection between bedrock and near-surface aquifer materials occurs.

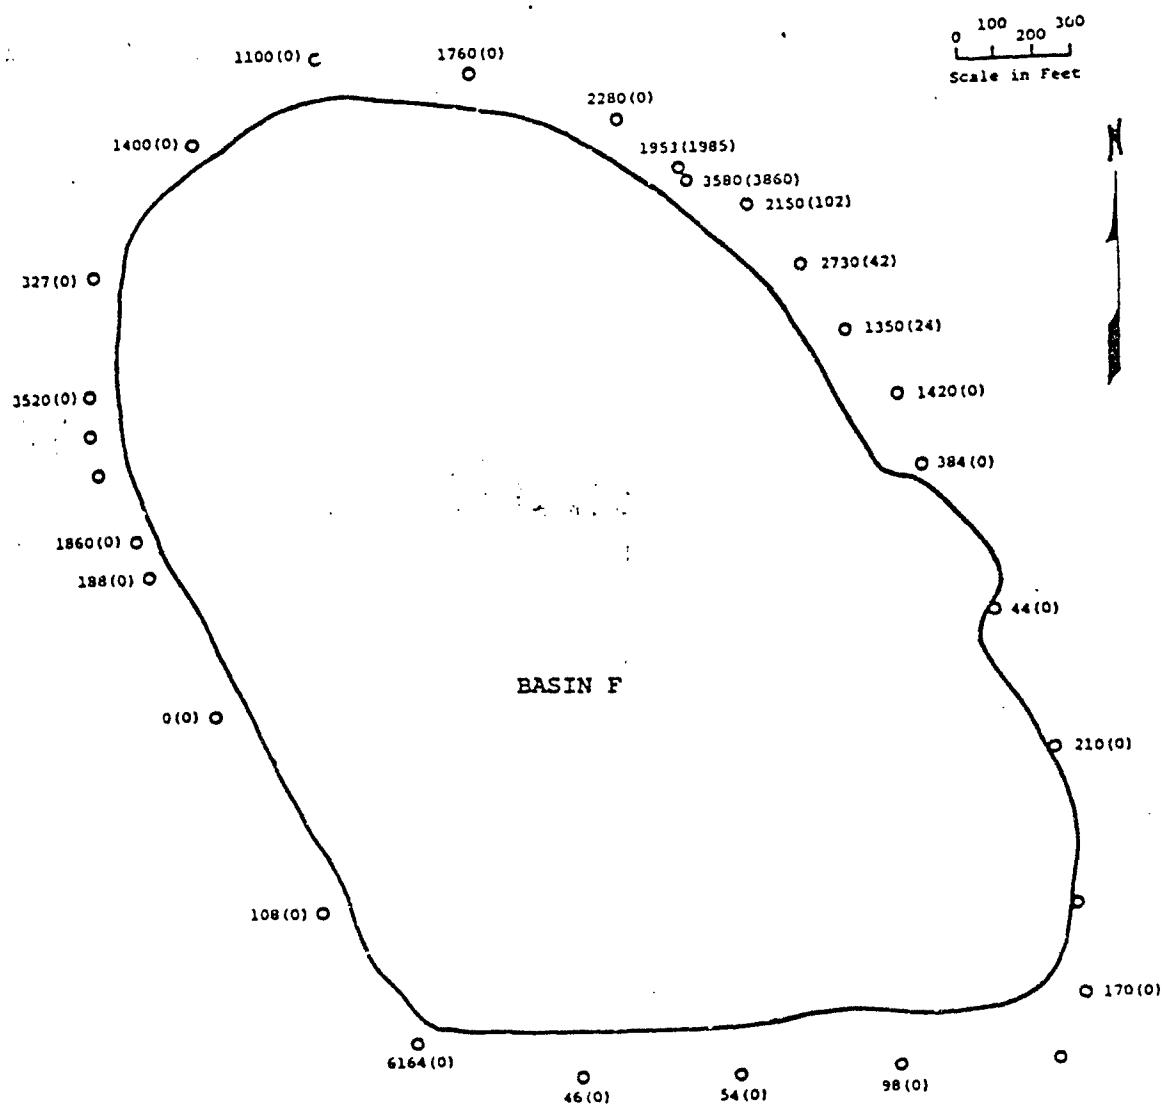
Figure No 4. Distribution of DIMP and DCPD (PPB),

Probably the two organic contaminants of greatest interest are DIMP and DCPD (Figure 4). DIMP was identified in nearly all the wells, but DCPD occurs only in the wells on the northeast corner in the vicinity of well 26-8 (#118). The low DIMP value at site 421 (74 ug/l) and the high DIMP value at site 422 (3520 ug/l) are not readily explainable. The same high-low relationship exists between sites 425 and 426. One explanation may be analyses error and water samples have been resubmitted. At the time of this writing the requested data has not been received. If, however, it turns out these original differences are, in fact, real, then a physical reason must exist. The only logical explanation may relate to the fact that the higher values occur in water moving through the bedrock sand. Although the saturated total thickness does not vary much, the well at site 421 which shows the lower DIMP value has a greater thickness of near-surface aquifer material than at site 422. This may indicate that the bedrock sand is transmitting contamination underneath Basin F from possibly the southeast part of the basin. The high-low relationship between sites 425 and 426 cannot be explained this way. These differences could be the result of a very narrow leak point out of Basin F or simply an analysis error. Further investigation is warranted. It is interesting to note that DCPD is only identified on the northeast side of Basin F.

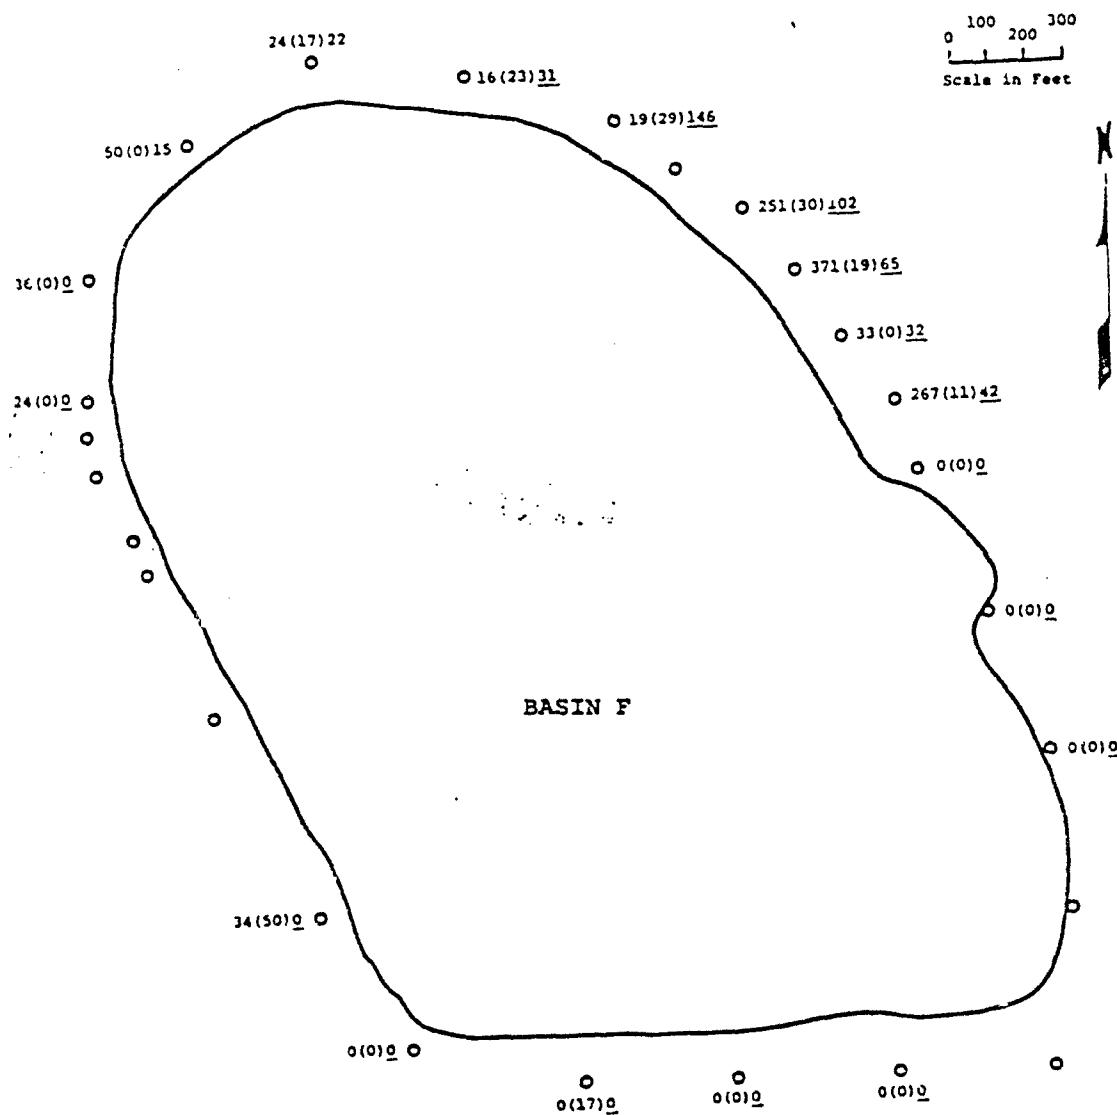
Figure No 5. Distribution of Organo-Sulfur Compounds, (PPB)

Figure 5 shows the distribution of sulfoxide, oxathiane and dithiane around Basin F. No sulfone was detected in any of the wells. According to the data on analysis performed on Basin F fluids, no oxathiane was detected although dithiane was found in some places. The presence of these compounds in the wells around the basin are generally restricted to the east and northeast side. The fact that some sulfoxide and oxathiane is found on the west side but at concentrations just slightly above detectable may be due to analytical interferences rather than real occurrences.

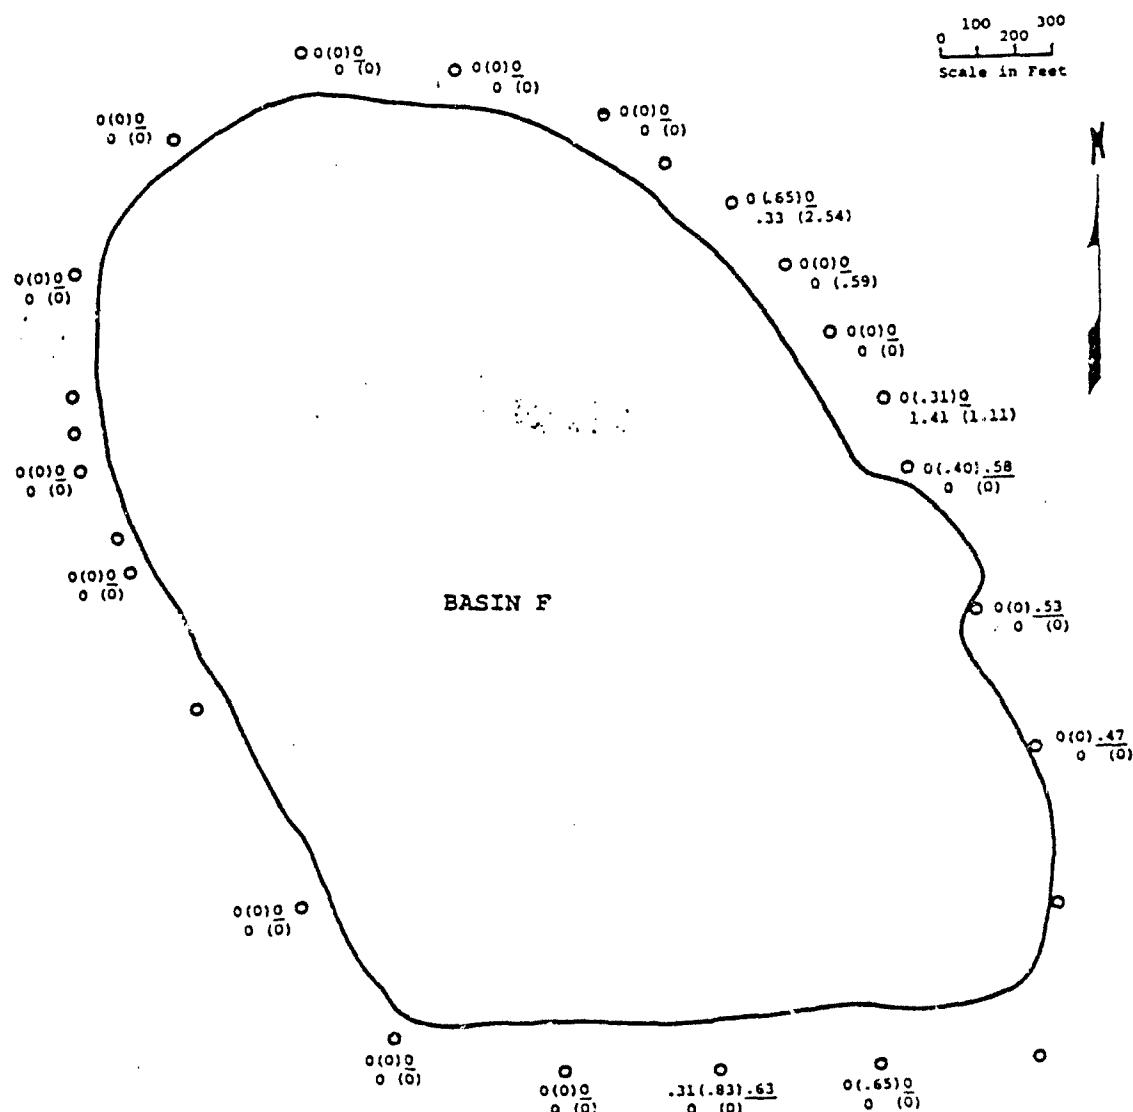
Figure No 6. Distribution of Chlorinated Hydrocarbons (PPB)

The chlorinated hydrocarbons (aldrin, dieldrin, endrin, isodrin, and DDE) are detected in only a few wells (Figure 6) on the east and south side of Basin F. DDT was not found in any of the water samples. The study on Basin F fluid and sludge determined that there was no detectable DDT or DDE present. In most instances the levels of the chlorinated hydrocarbons are barely above detectable levels. Nor do these compounds appear in water near the vicinity of well 26-8 (#118). The presence of these compounds in the groundwater may be due to a source other than Basin F. It is known that the sanitary and contaminated sewer lines run along the east side of the basin and most the chlorinated hydrocarbons are found in the wells that parallel the sewer lines.

- f. It seems likely that the sewer lines along the east side of the basin, particularly the sanitary sewer, contribute some contamination to the groundwater system. The sanitary sewer is probably the source for the chlorinated hydrocarbons.
